Drinking water 2019

Quarter 1

A report by the Chief Inspector of Drinking Water

Northumbrian Water – Horsley WTW Fluoridation Chemical Spillage

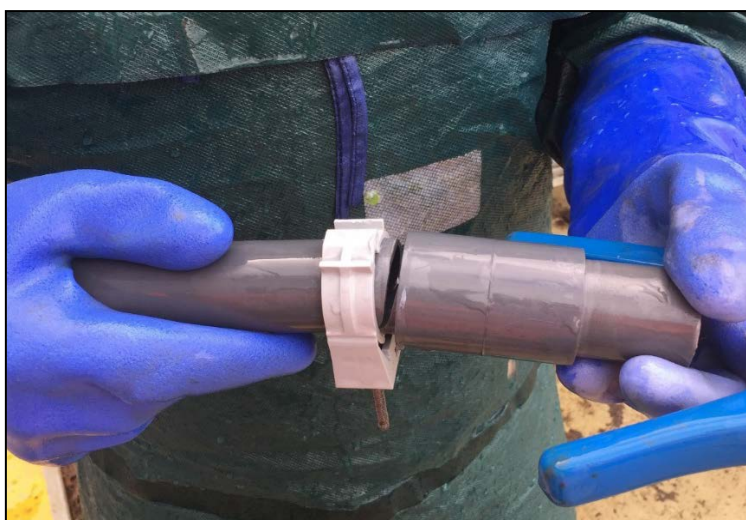
Figure 1. Fractured pipework

The root cause of the leak was a fractured pipe between the bulk HFSA storage tank and the transfer pump. This pump and its associated pipework were contained within the concrete bund. The cause of the fracture remains unknown, but the company concluded that it may have been caused by vibration, possibly from a recent operation to erect scaffolding around the bund. This pipework was not double-skinned or otherwise protected. The size of the fracture can be seen in the photograph below, provided by Northumbrian Water:

The HFSA bund alarm was not activated. This was a float-activated alarm positioned in the sump of the bund. The company investigated the reason for its failure, and found that it was positioned too high. The float-switch itself was not faulty.

As part of the investigation the Inspectorate concluded that the Code of Practice had not been fully complied with because the bund alarm had not

been installed correctly. A further concern is whether concrete bunds are suitable for HFSA storage and delivery facilities. In this case it potentially took less than 7 hours for the acid to penetrate the internal epoxy coating, degrade the concrete and leak into the surrounding area. The company's risk assessment of the installation failed to take into account the short-term protection afforded by this coating.

The company has implemented some changes to its internal procedures to reduce the risk of a recurrence, and is reviewing the design standard for HFSA storage facilities. The company has also shared the findings from this event with other water companies through the cross-industry fluoridation forum.

Water suppliers are advised to review their design standards for chemical storage facilities and liquid chemical bunds in particular, to ensure that they are fit for purpose and that the risks associated with treatment chemical leaks are understood and considered, where appropriate, in company's drinking water safety plans.

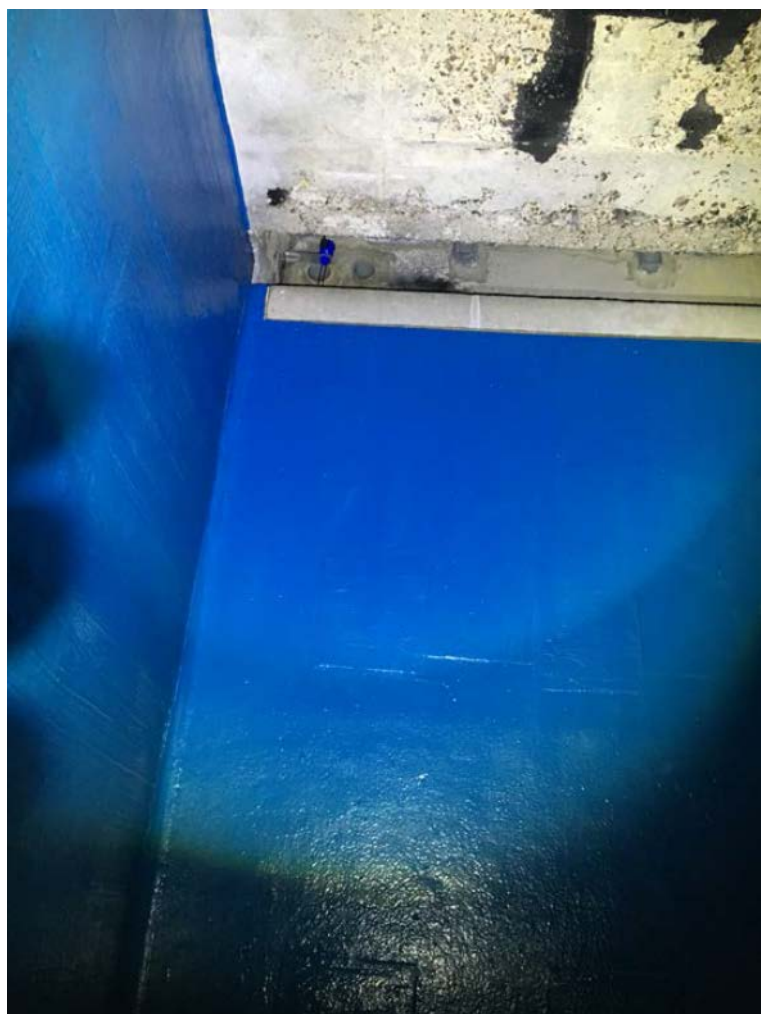
Figure 2: Gap between Weirwood Contact Tank & Backwash Tank

Southern Water identified a risk that partially treated backwash water could enter the contact tank at Weirwood works, as it could overflow a dividing wall between the two processes. The company installed depth transducers to monitor the backwash water level, however, the physical link presents a high risk as a potential route for partially treated water entering the contact tank and the process to be bypassed. Consequently, the Inspectorate recommended that the company investigates suitable remedial measures to mitigate the risk to disinfection.

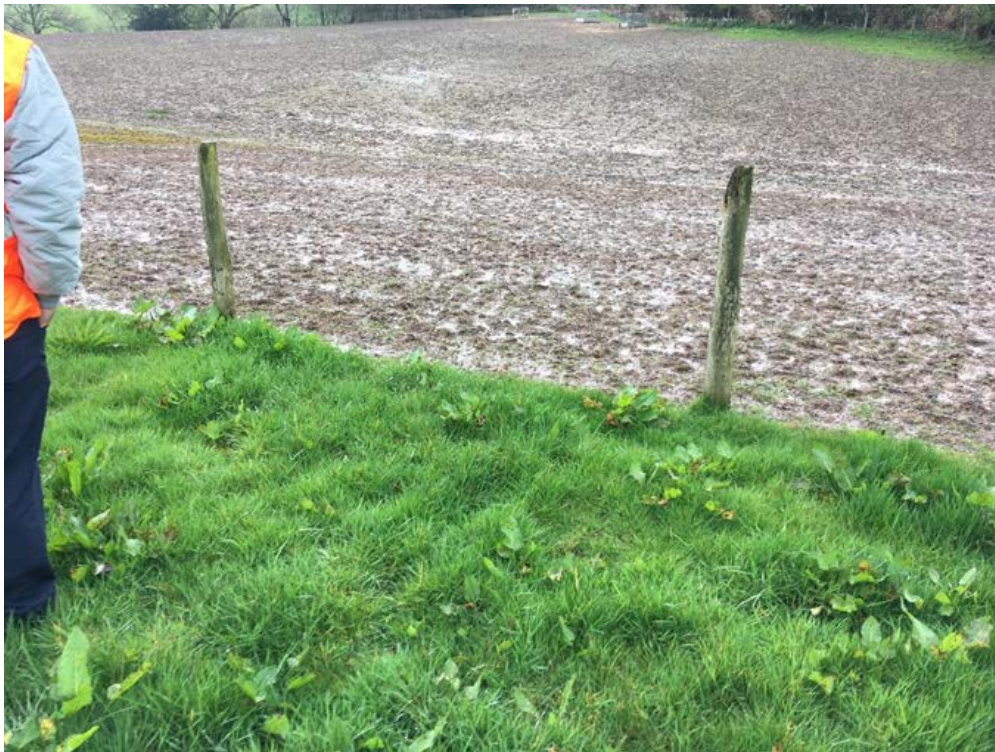
Figure 3: Waterlogged field adjacent to Talybont Contact Tank

The contact tank at Talybont works is situated adjacent to a field used for livestock at roof level. At the time of the audit drainage was poor; one of the hatches had ivy growing around it and sealant was becoming detached from another hatch. There was also some evidence of animal burrowing. The company subsequently took steps to address all issues except the animal burrowing.
